# ***GALLIPOLIS LOCKS AND DAM***

**FOUNDATION REPORT**

**VOLUME 4 PHOTOGRAPHS**

**CONSTRUCTION OF TWO PARALLEL LOCKS AND CANAL**

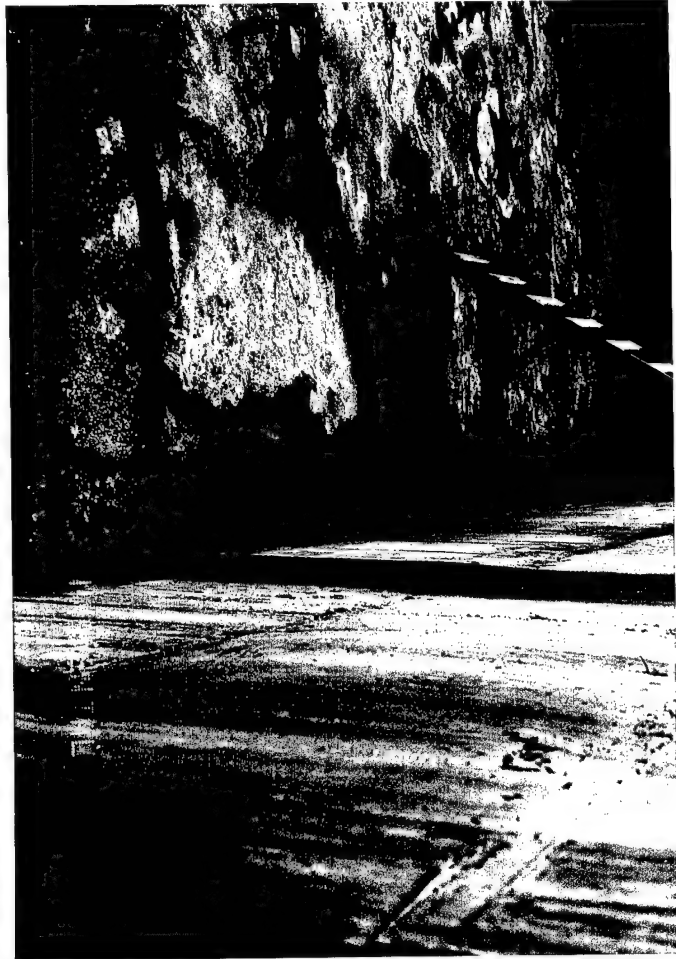
(214) R-38 Invert view looking East after repair

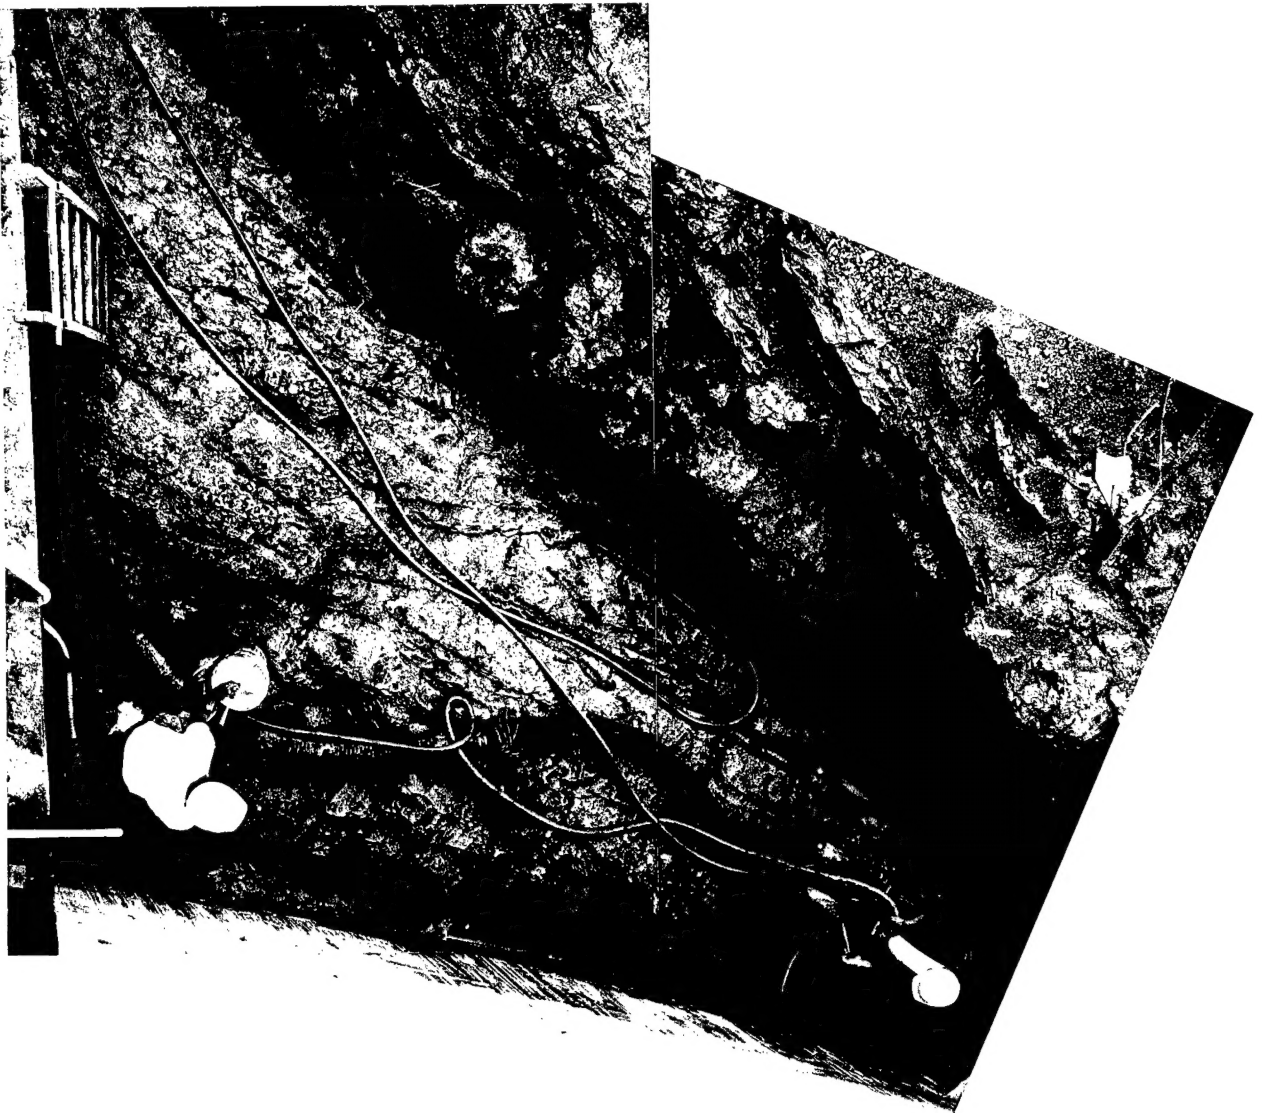
(262) USAMGS-10 View of slip looking Southwest
